## **TOWN OF GREENWICH, CT – Representative Town Meeting**

## **Request for Funding to Repair and Remediate Modular Facility**

## Conceptual Estimate Remediate/Repair of Existing Modulars

## **Executive Summary**

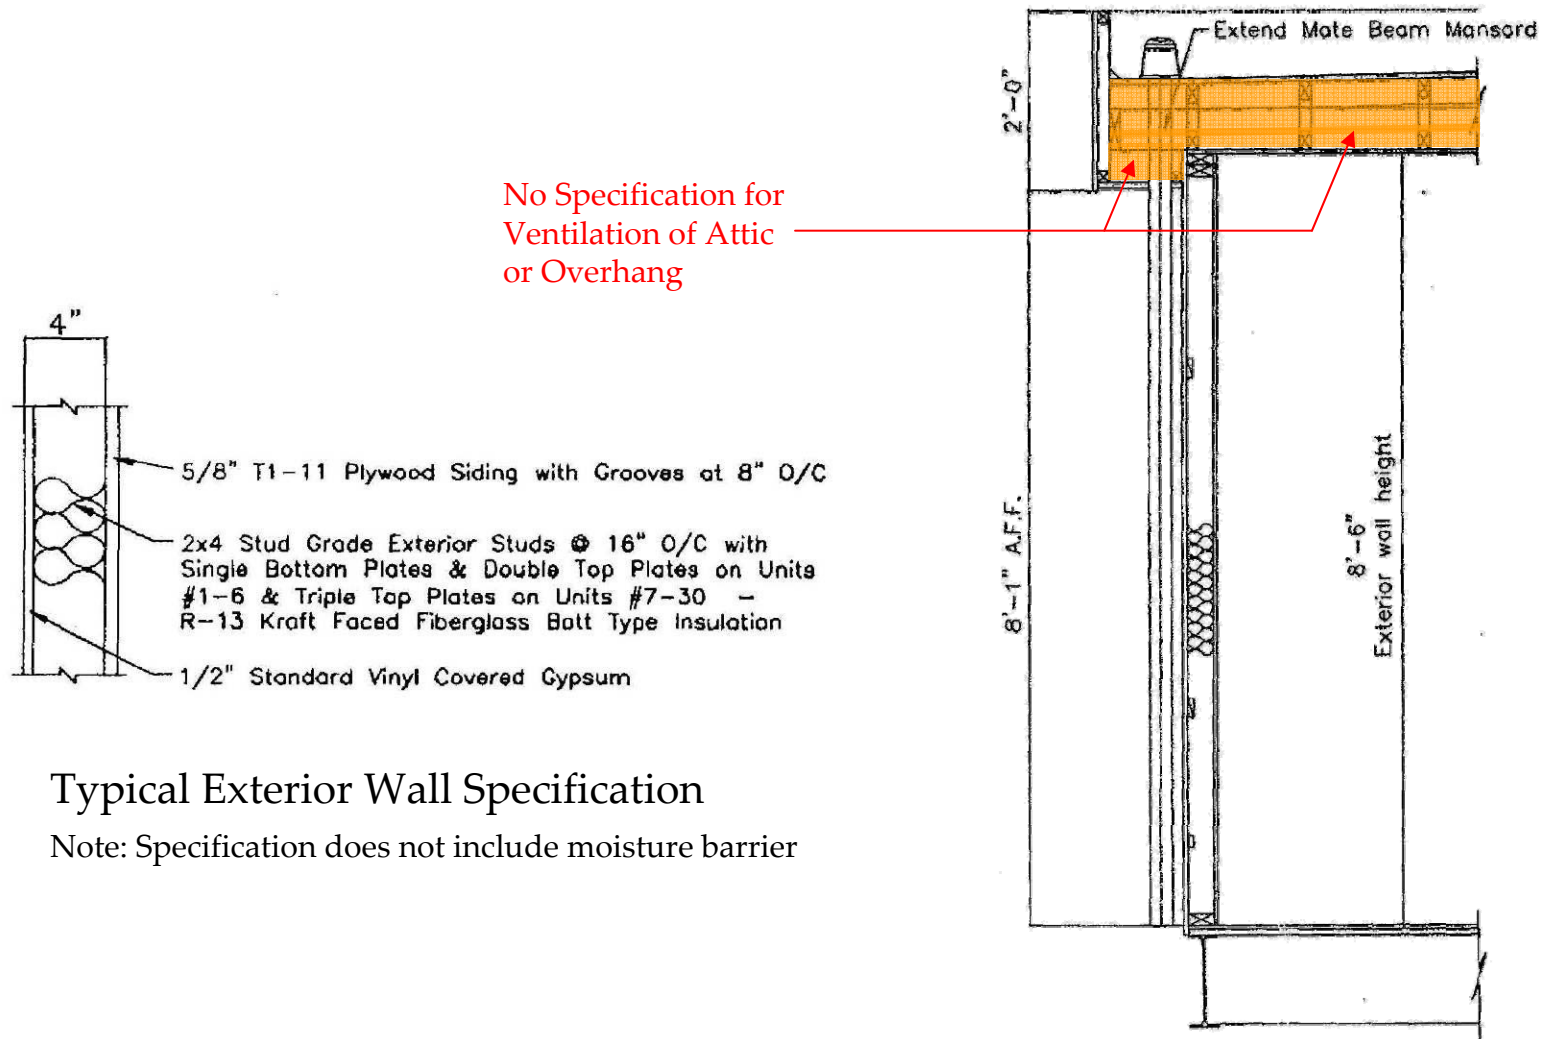
Typical Exterior Wall Section

Note: Specification does not include moisture barrier

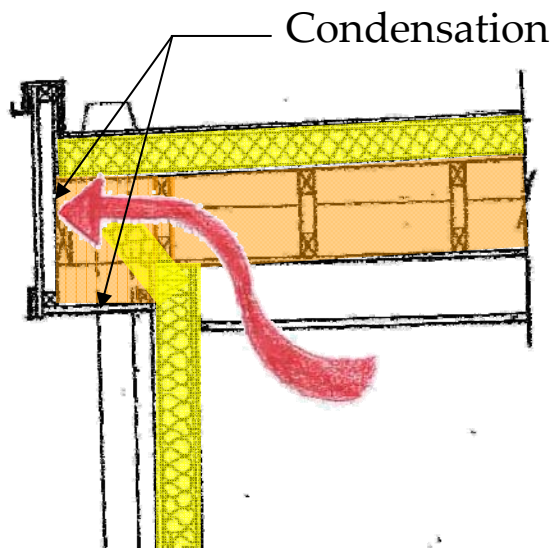
Improperly Installed Insulation

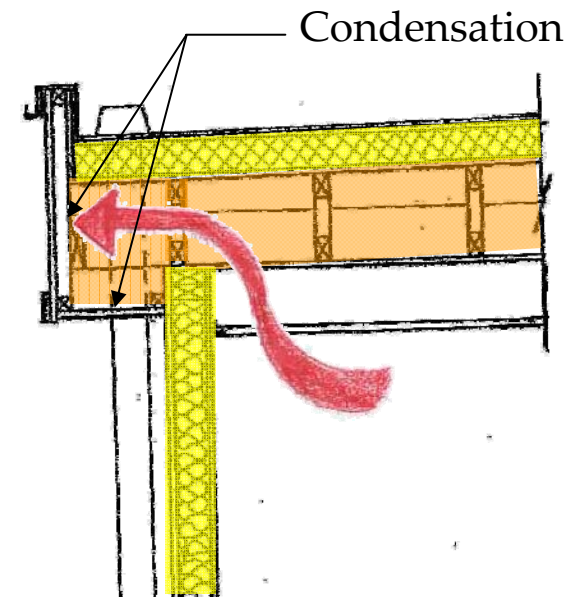
No Insulation

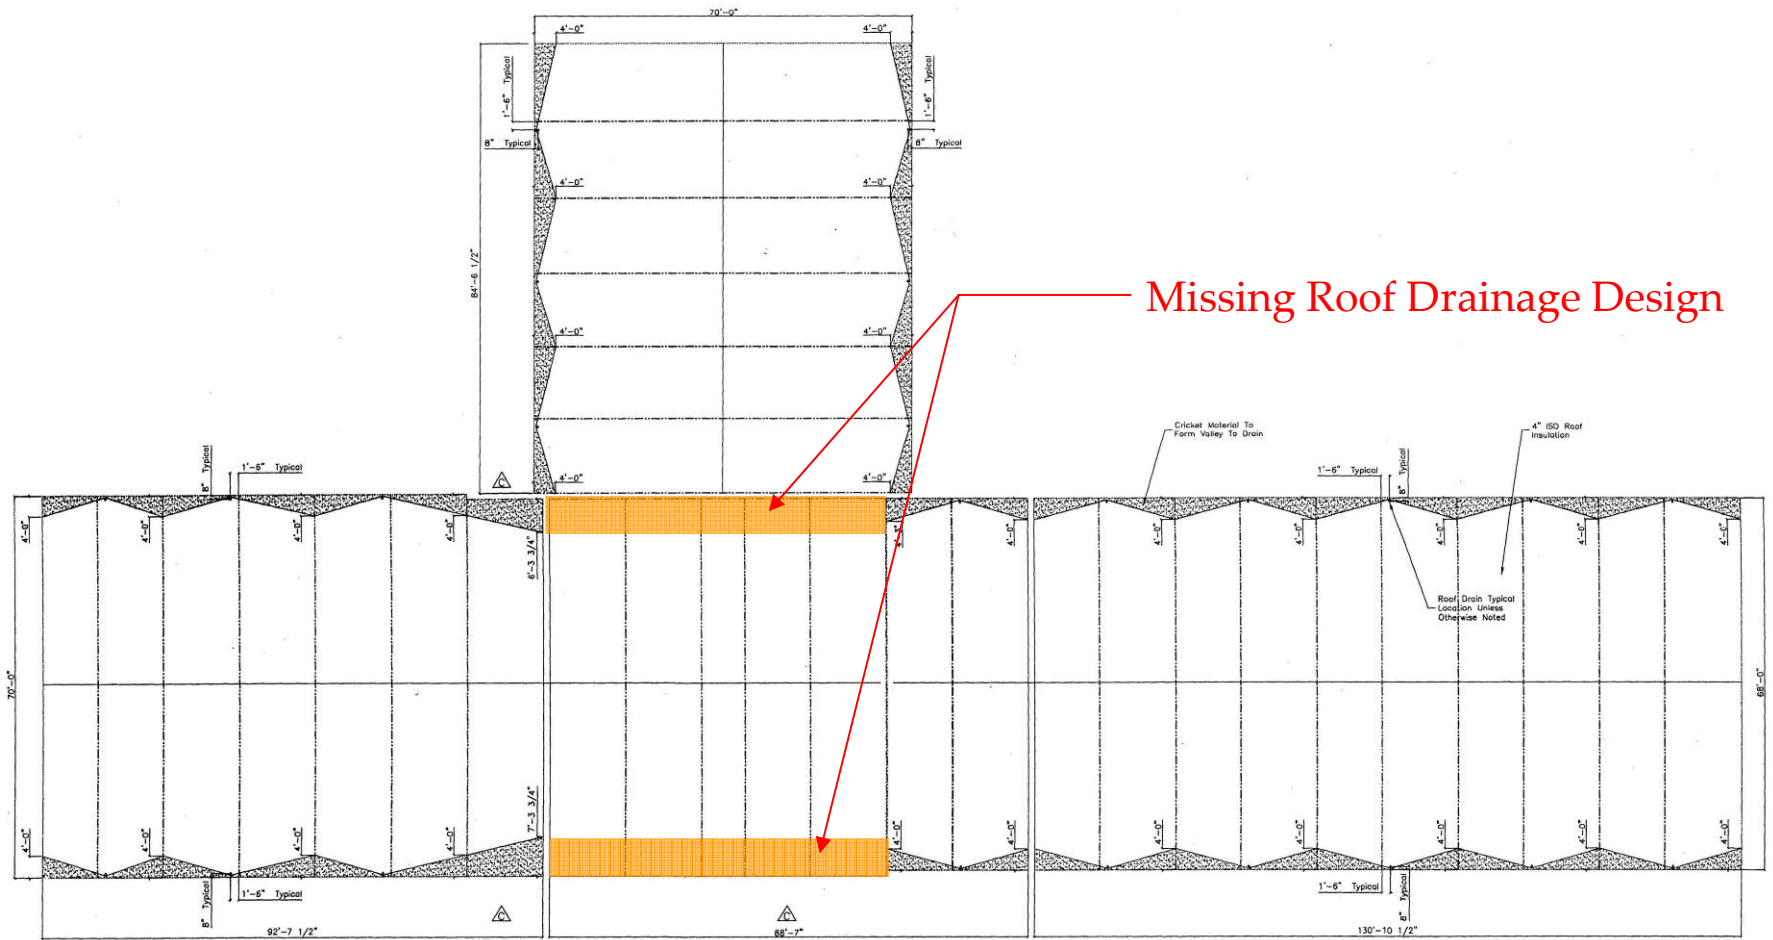
# Roof Plan

The roof of the buildings is in good overall condition. However splicing and termination details of the roofing membrane provide many places where water can enter below the membrane and travel down the slope of the roof deck into the soffit.

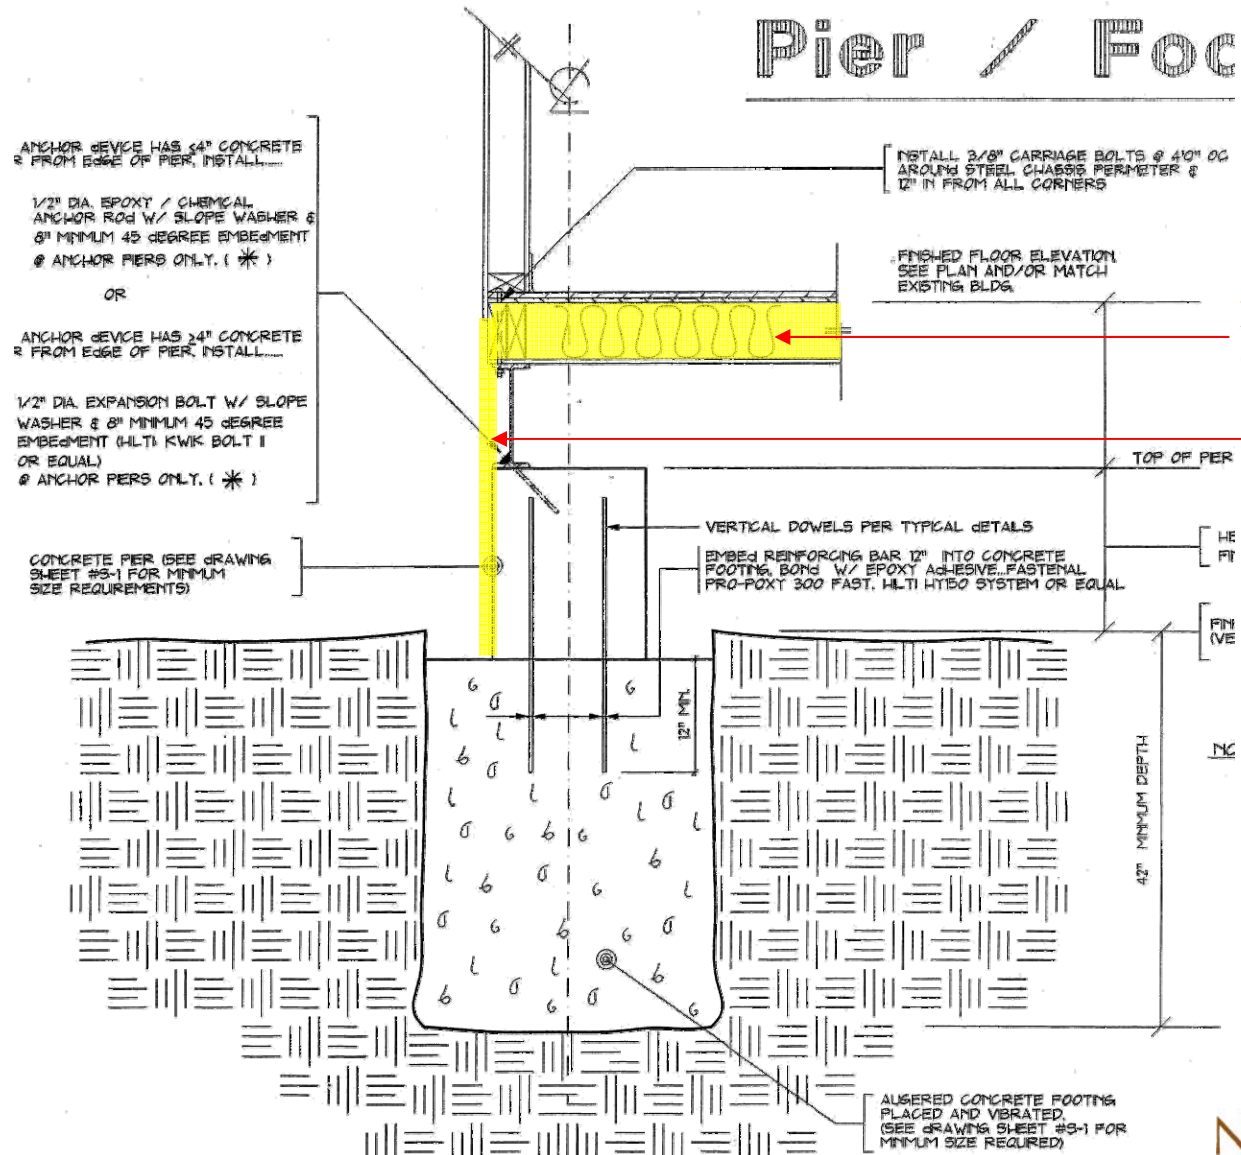
# Footing Detail

Incorrect Floor Construction

Skirt Not Designed

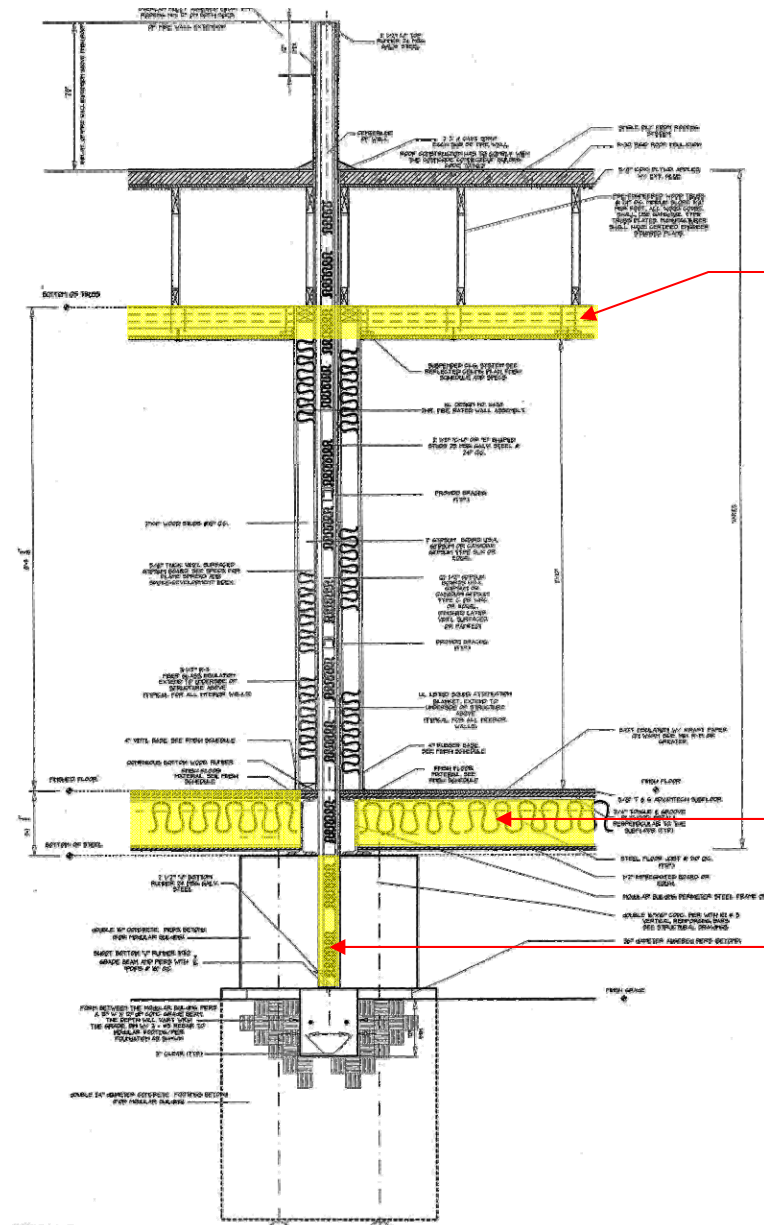
# Firewall Detail

No Drywall Ceiling Shown

Incorrect Floor Construction
